**DOMINION VOTING SYSTEMS  
InterScan 821D HiPro Scanner  
Modification to DemSuite 5.2  
Administrative Approval Report**

**Components:  
InterScan 821D HiPro Scanner,  
Dell OptiPlex 7040 Workstation,  
ImageCast Central Version 5.2.2.7**

**Staff Administrative Approval Report  
Prepared by:  
Secretary of State's Office of  
Voting Systems Technology Assessment  
May 8, 2018**

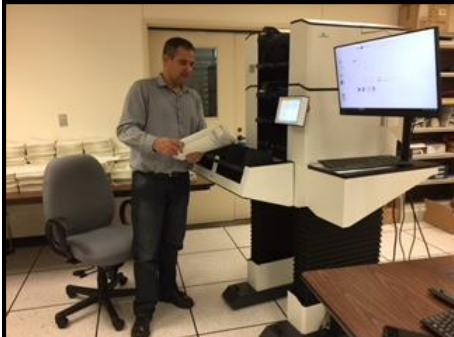
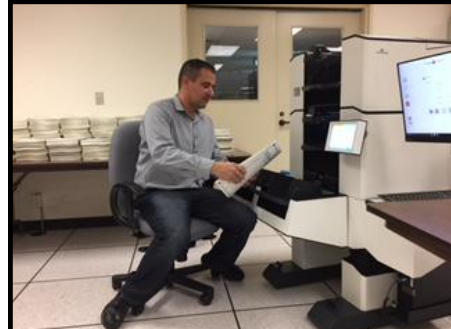
The Interscan 821D HiPro scanner, while not a voter usable device, includes the ability to lower and raise in order to accommodate an elections office worker.

It was found that the Interscan 821D HiPro scanner is easily adaptable for sitting or standing elections workers. It was determined that the technologies implemented for accessibility and usability in the Interscan 821D HiPro scanner improved the experience for election workers that may be required to spend hours at a time operating the Interscan 821D HiPro scanner.
